SCOUT Projects:

m/v SCOUT (Great Harbour N37)

Description

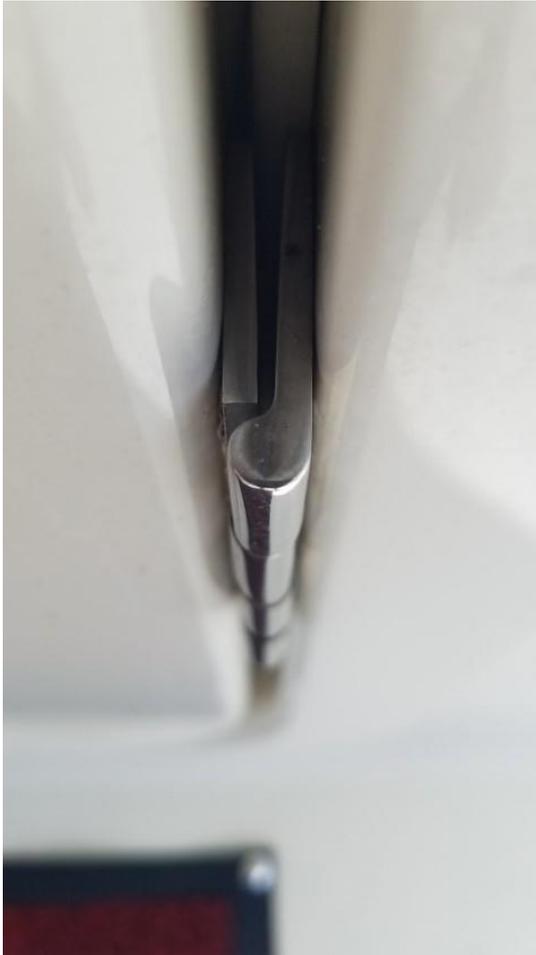
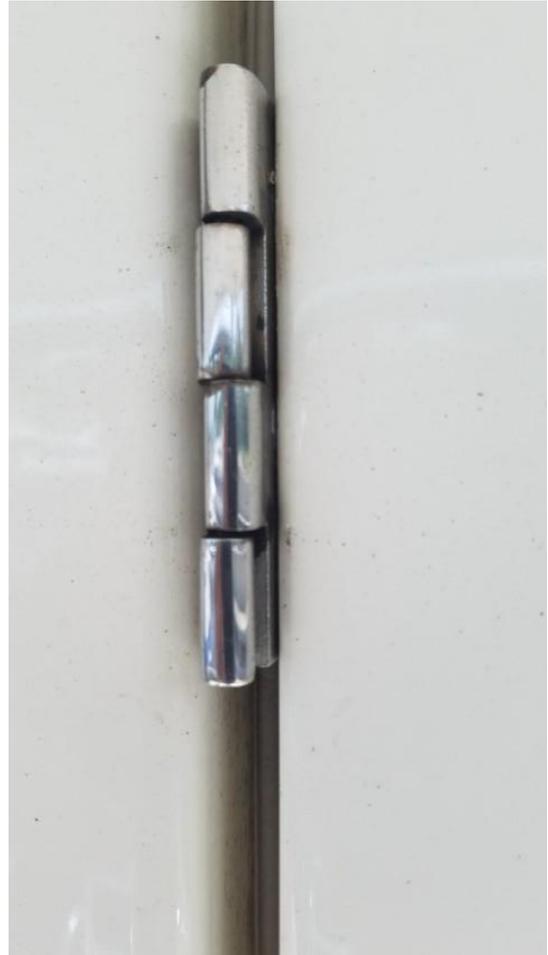
As stated above, we could not find anything reasonable to replace the original hinges with and keep the same arrangement. One of the problems is that, to fit within the confines of the door frame with the leaves folded, the hinge pin must be very small in diameter. Several of our hinges were in bad shape, the pins nearly rusted through.

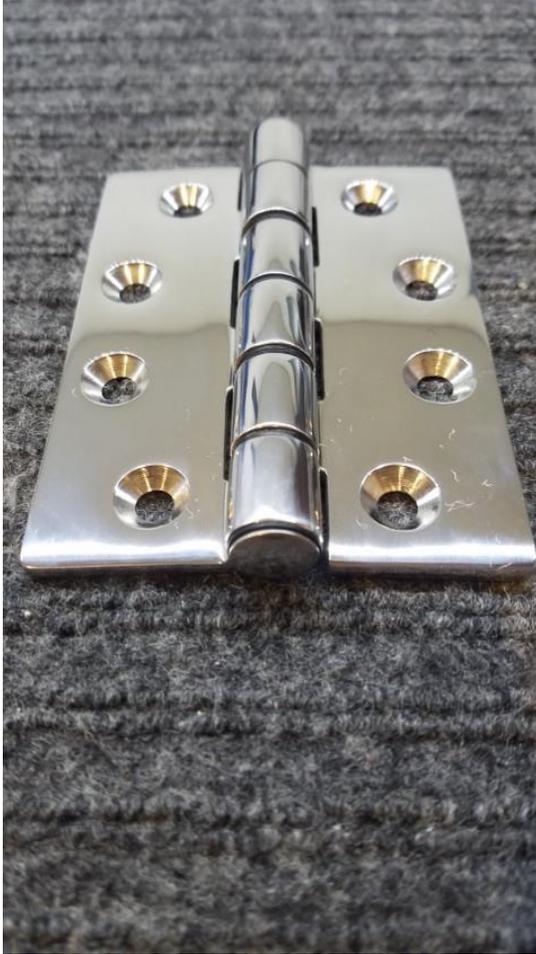
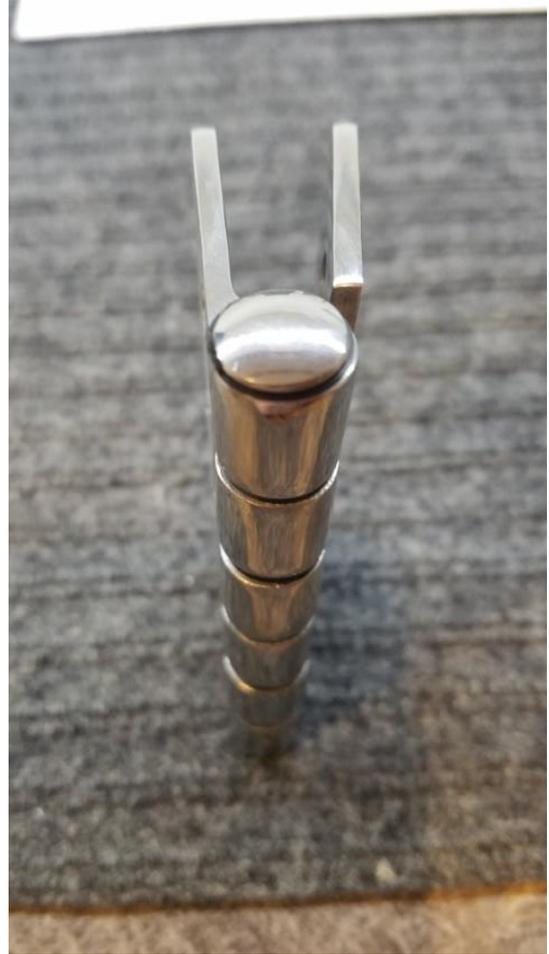
Reluctantly, based on the near-impossible dimensions required for in-frame folded hinges, I decided to use a butt hinge on the *exterior* of the frame so that a more robust, large pin, and easily-sourced hinge could be used. We settled on the Sea Dog #205243 cast 316 stainless hinge. It is very stout, has nylon bearings, a captive pin, and an architectural finish.

One of the advantages to the folded-leaf hinge within the door frame is that when the door is closed and locked, the screws are prevented from being removed by nefarious persons in order to compromise the door. In order to partially alleviate this problem with an externally-mounted butt hinge, we used tamper-proof mounting screws.

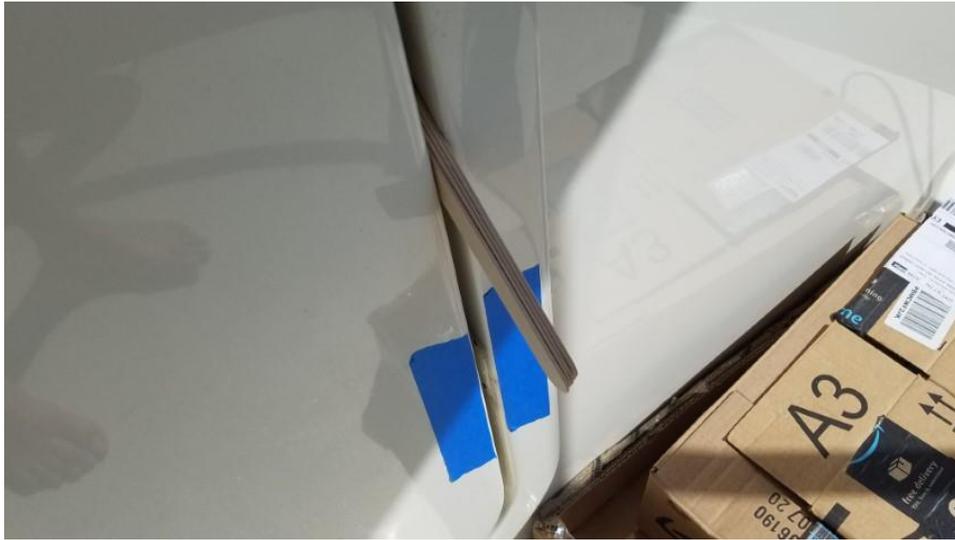
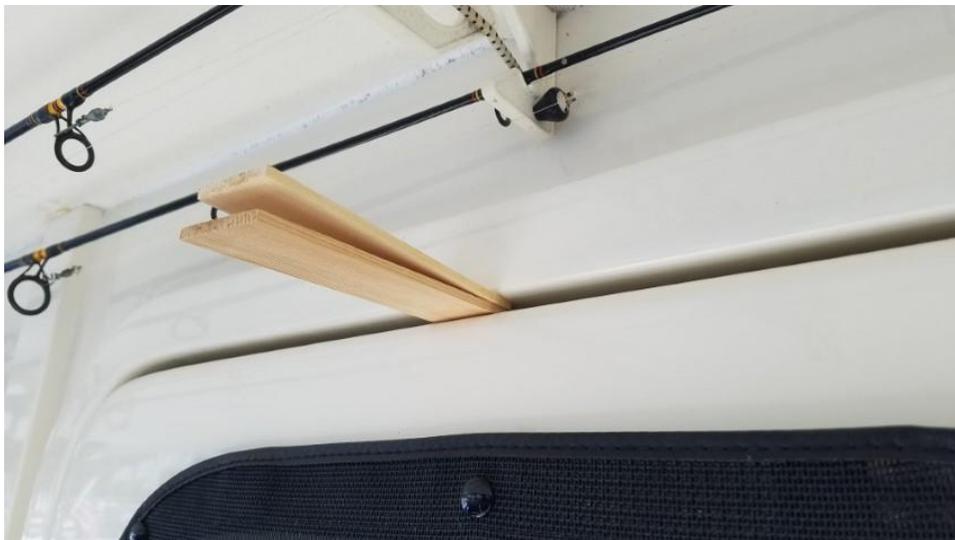
One of the advantages of “starting over” with the new hinges is that I could (re)center the doors within their frames. The cockpit door was off to one side by quite a bit – having a large gap on the starboard edge and the top. I shimmed the door with to center it in the frame before templating and drilling the new hinge screw holes. This involved completely removing the door and setting it back in the frame, wedging it in tightly with various popsicle sticks and wood shims to even out the gaps.

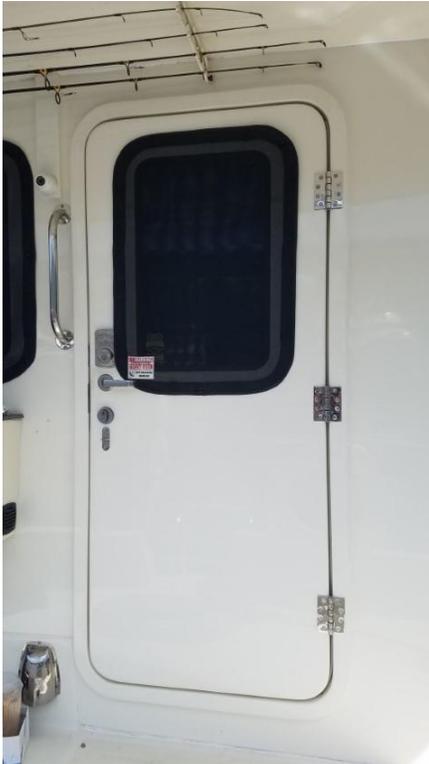
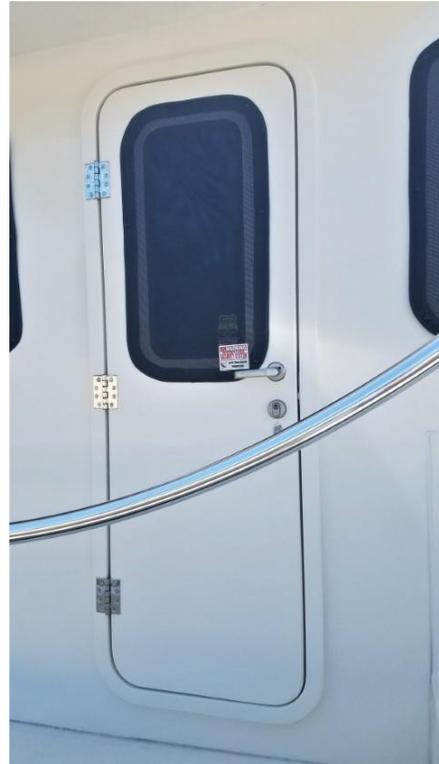
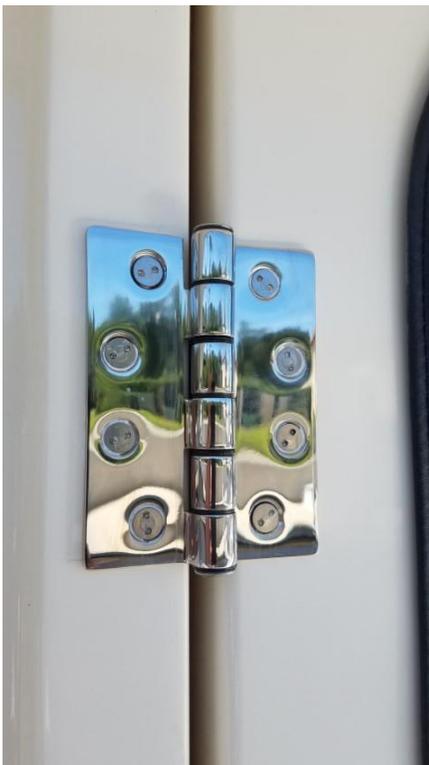
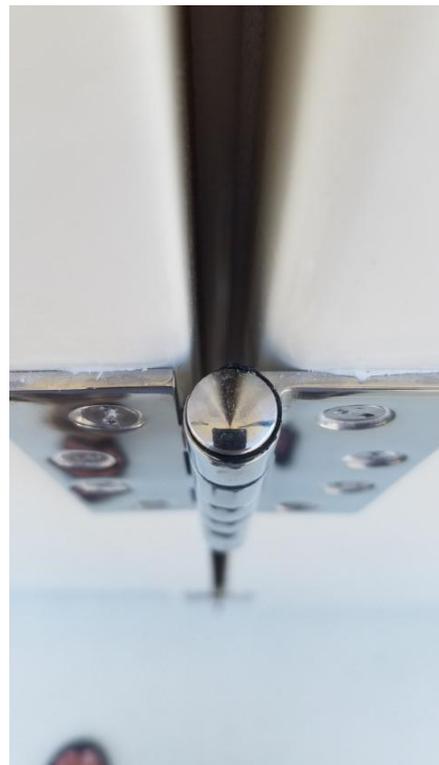
I was a bit worried about the aesthetics of the external hinges, but after seeing them on the boat, I think they look really good and compliment the “no bling”-ness of the N37. They sure do feel solid and swing smoothly now.
