SCOUT Projects: *Hatch Support Reinforcement*

m/v SCOUT (*Great Harbour N37*)

Reinforce sagging hatch supports to bring hatches back to level.

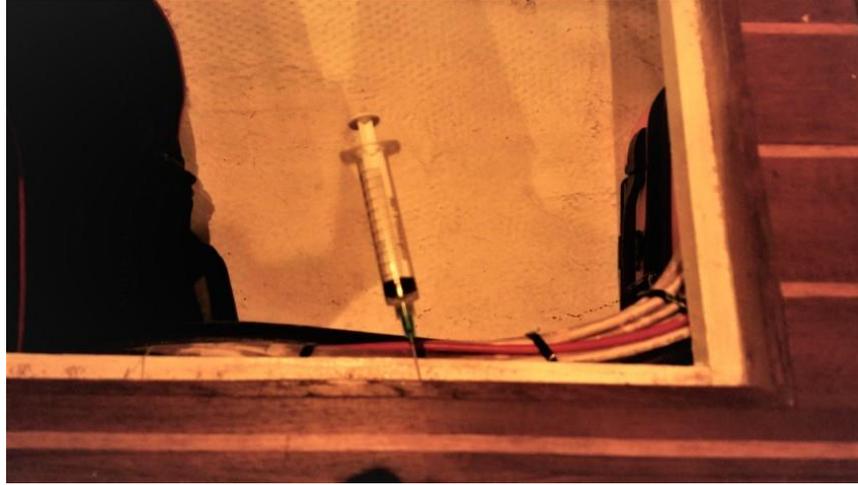
I used a chisel/wedge to open the existing gap along each support and injected slightly thickened epoxy as far into the crack as I could using a glue syringe.

TIP: Use the syringe *without* the needle cap screwed on to first suck up the epoxy. Then (sloppily) screw on the needle tip to inject.

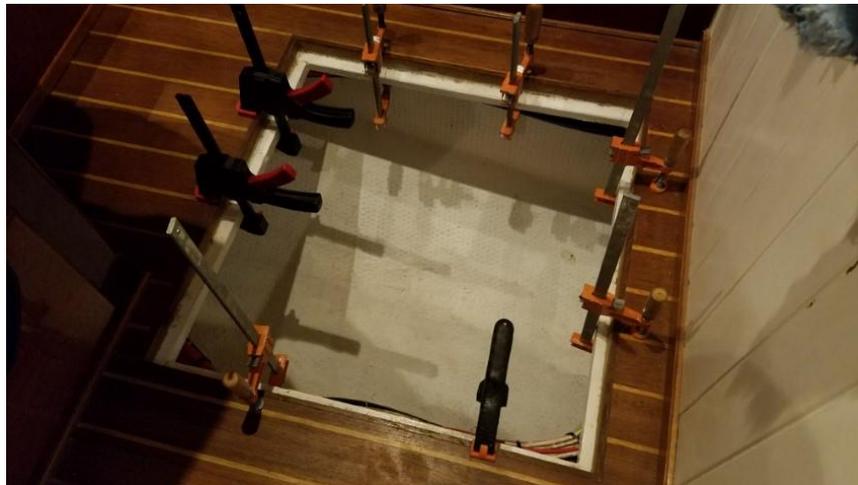
After the epoxy was injected all along each of the support lengths, I clamped them all the way around until the epoxy set up. The clamps just forced the original screws back into the wood holes that were already there.

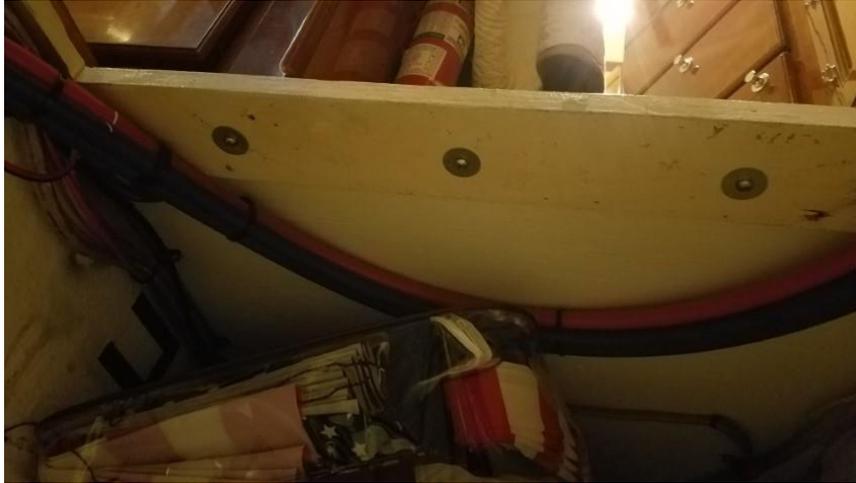
After the epoxy had set up, I came back around to all the supports and screwed in some large #12 screws (as far into the flooring above as I dared) with huge fender washers, adding additional support.

The hatches are now perfectly flush with the floor and are rock-solid. A side benefit is that there is not a single groan, creak, or squeak when stepping on them anymore!
