SCOUT Projects:

m/v SCOUT (Great Harbour N37)

Description

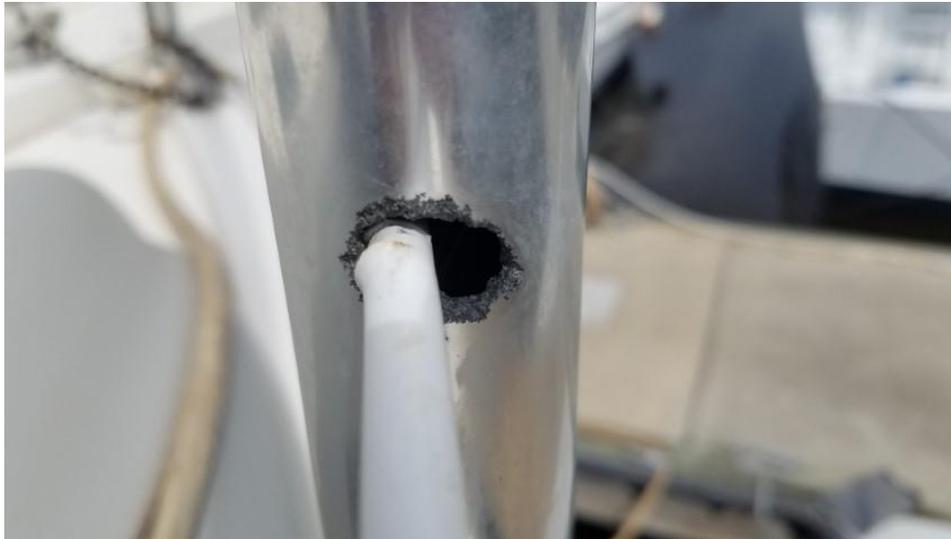
The vinyl coating on the stainless wire had chafed through at the aluminum station hole and bare stainless steel was rubbing against aluminum (bad). Add some saltwater, and this is what you get:

After looking at all of the other stations, I can't for the life of me figure out why someone wouldn't spend the extra **37.3 seconds** that would be required to round over the "knife edge" that the raw drilled hole provided --- to perfectly slice through the lifeline covers. So instead, I have this to deal with.....Sheesh!

Two of the holes were nearly this bad, and one other just beginning – luckily the others hadn't started yet.

I wanted a way to eliminate any chance of future chafing. I thought about rubber grommets, but I was pretty sure the UV exposure would destroy them in a matter of weeks. I decided instead to try some hard plastic "snap-in" grommets. They would require drilling a larger hole in the stantions, but the slightly larger size didn't appear to me that it would reduce the strength of the stantion due to the rigid rail connections above and the deck plate below.

The relatively huge hole in the corroded stantions didn't require much overdrilling for the grommets, but I needed a way to fill the oval gap. I thought about getting a welder to close them up and re-drill, but dreaded the thought of scheduling, explaining, polishing, etc.

Since the repair didn't appear to be structural, I decided to just overfill with thickened epoxy when the grommet(s) were inserted. I did order some 'silvery' epoxy tint to try to help it blend with the aluminum and also protect from UV. It turns out the color of the white high-density filler overpowered nearly all the 'silvery' stuff, though. We'll just keep an eye on them to see over time what the UV does to it.

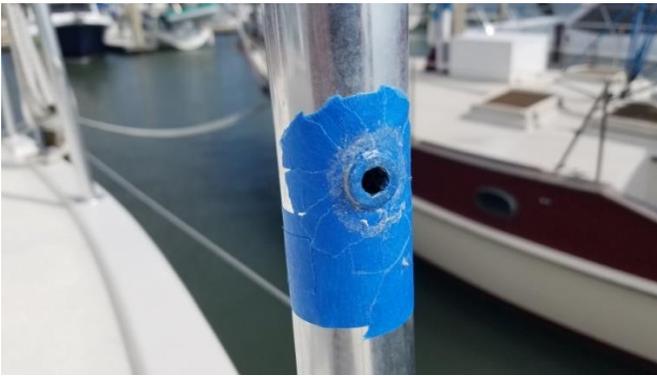
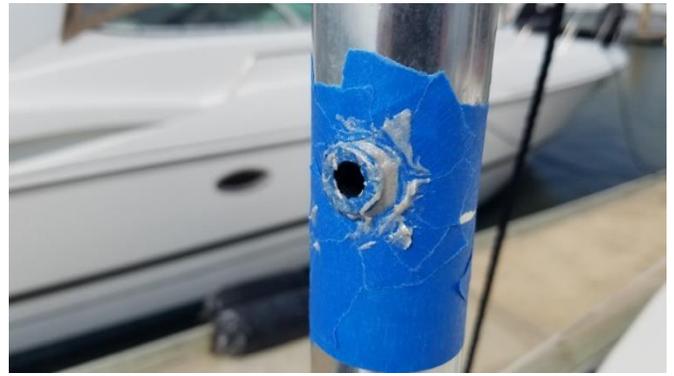
I redrilled all of the stantion holes, cleaned them up, and treated the exposed areas with metal etching primer to get better adhesion and protection from the epoxy. Once cleaned and dry, I taped off the hole area, laid in some epoxy, and inserted the grommets.

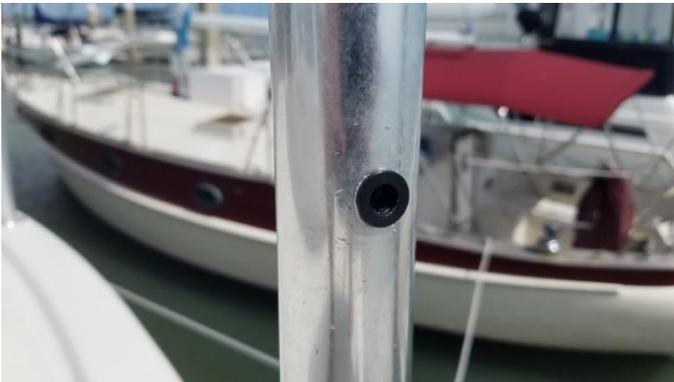
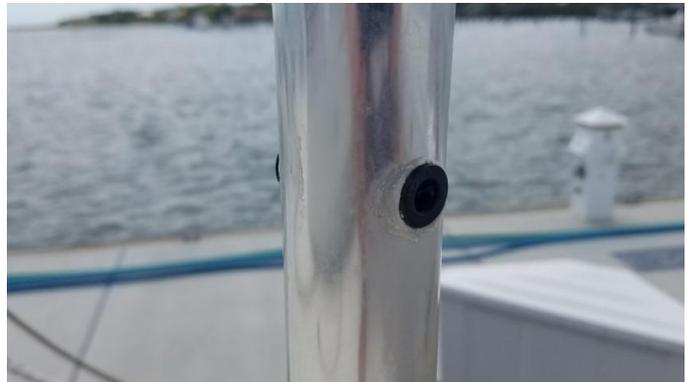
To make things easier, I removed the blue tape after the epoxy was only partially dry. The filled epoxy section didn't come out nearly as pretty as I had hoped, but it will have to do for now as it is only a cosmetic imperfection.

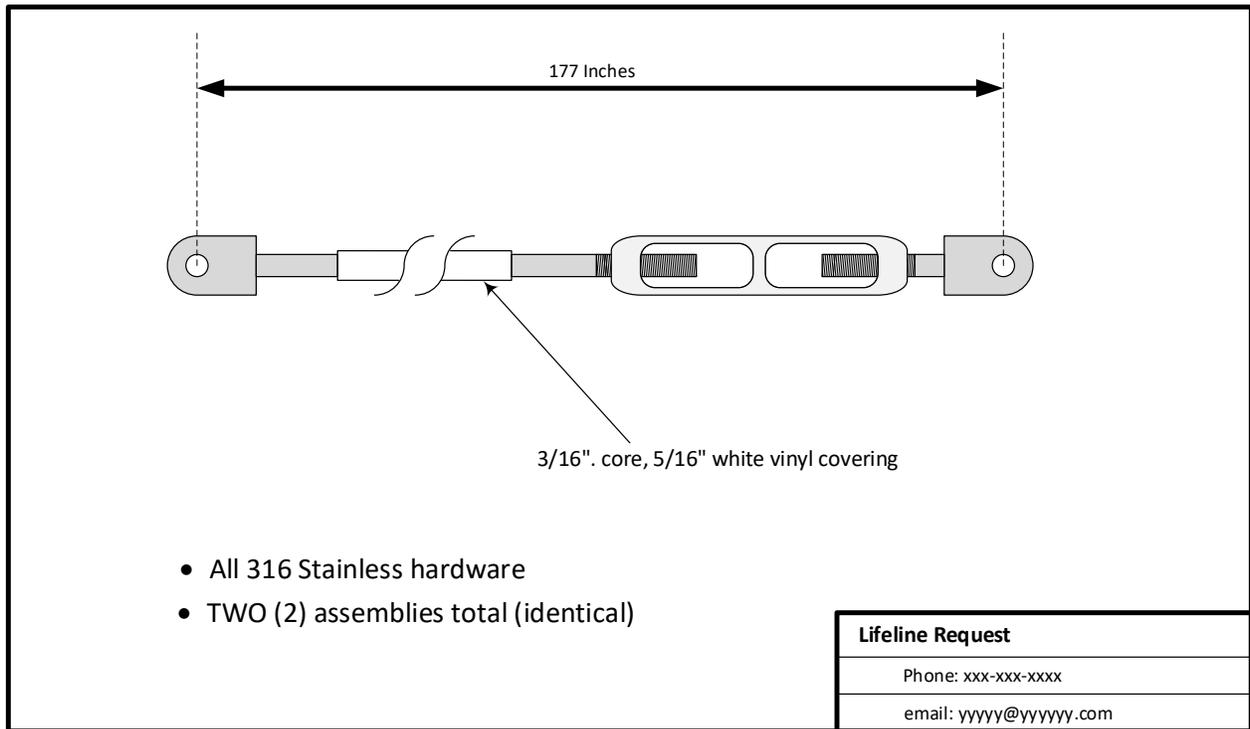
I received exceptionally good service from the rigger to whom I sent a drawing to for the replacement lifelines. The numbers I included in the drawing below are for *OUR BOAT* – measure carefully if you use this drawing and ensure your boat is not different. For our boat, I use the mid-thread position on the turnbuckle so that it could be made somewhat longer or shorter when received. It turns out there was about a 1/2" difference between the port and starboard sides.

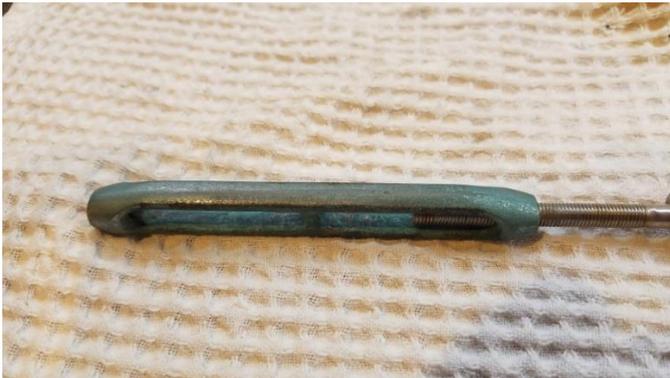
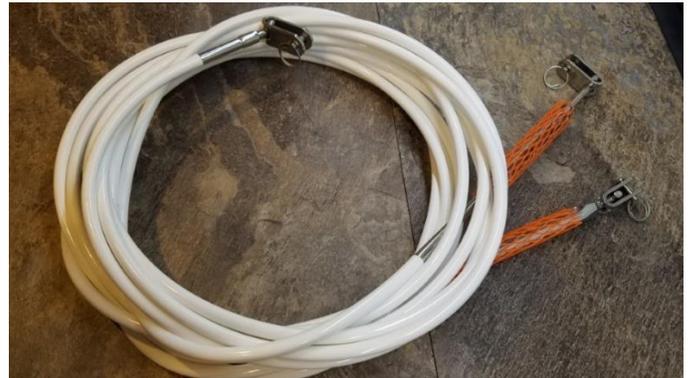
The lifelines looked good when received – it was nice to have 316 stainless turnbuckles instead of the zinc-plated ones that had been turning an ugly shade of green.

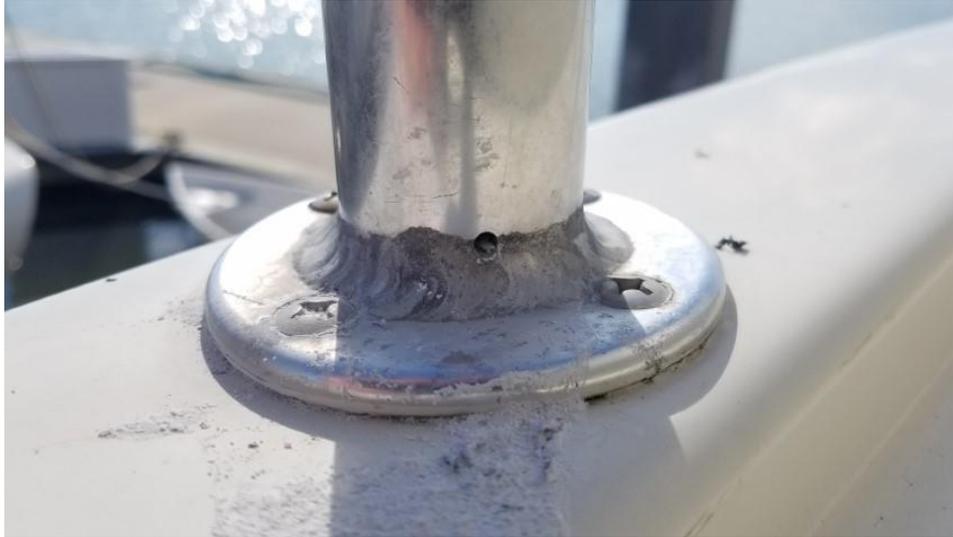
While looking at the holes in the stantions, I thought that this was a good place for water to get in and run down inside the stantion. I looked at the four bases of the drilled stantions and none of them had any weep holes in them of any kind. For these four, I drilled a 1/8" hole at the base to allow accumulated water to exit. Sure enough, when the drill bit came through, about 1/2 to 3/4 of a cup of water and "schmutz" came flowing out (white-ish stuff at the bottom in the picture) from each of the bases.

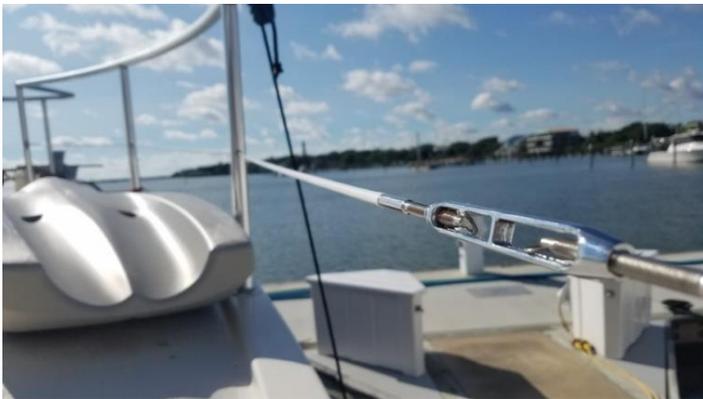
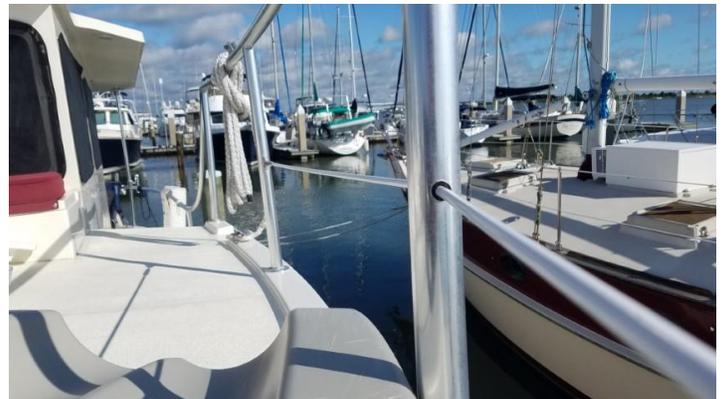
The opening in the grommets was exactly the right size for the vinyl cover diameter, but when the cables are swaged by the rigger, they 'fatten up' a little (likely to help with later shrinking). This meant that they wouldn't go through the grommets. There is a small inner flange on the hole, however, and a quick touch with the drill without damaging the rest of the sleeve made for a good fit.

While we could have done a better aesthetic job with the corroded-out holes, this at least puts a stop to the corrosion and hopefully prevents any future problems.
